Home Inspection Report

Address: 123 Any Street, Anytown, CA

Date: 08/09/2007

Apex Home Inspection

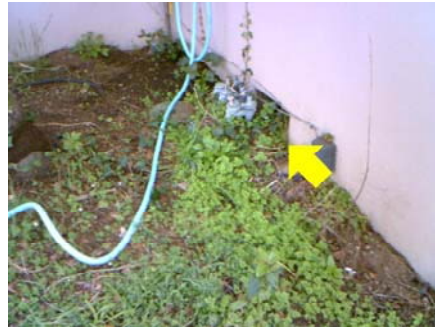
SITE CONDITIONS:

Moderate slope. General condition appeared serviceable with the exception of the following item(s): We recommend routing the gutter downspout terminations away from the home. This should help significantly with site drainage. The grade at the foundation appeared to be high at the left front of the home. We recommend lowering the soil level to prevent moisture damage and to deter pests.

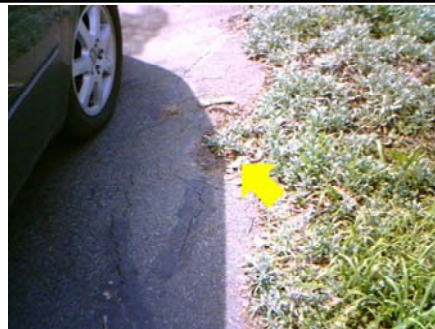
CONDITION:

General condition appeared serviceable with the exception of the following item(s): Common cracks were noted. We recommend sealing these cracks to prevent erosion. Damage is noted along the edge of the driveway. We recommend repair.

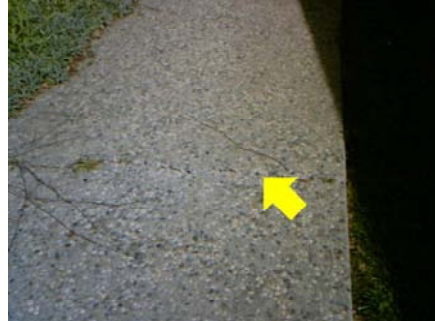
CONDITION:

General condition appeared serviceable with the exception of the following item(s): Surface raised/settled, tripping hazards were noted at the front sidewalk. This is a safety / liability issue. Correction is recommended.

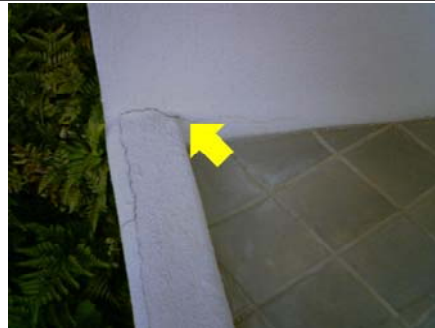
CONDITION:

The general condition appeared serviceable with the exception of the following item(s) listed below. Cracks in the stucco appeared to indicate settlement of the deck/porch. We recommend further evaluation and repair by a licensed contractor.

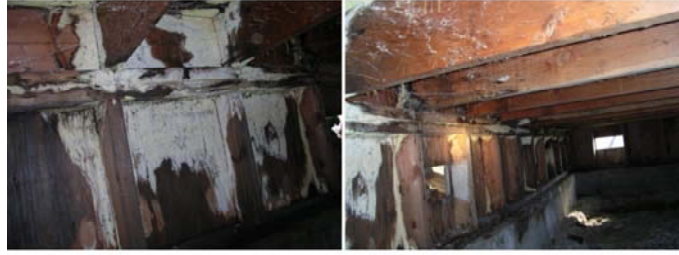
CONDITION:

Deck surface was covered. We were unable to fully view the deck. Cracks and damage were noted to the deck grouting and stucco on the railing. This material will not be waterproof. Leakage will damage framing members below. No drains were visible on the deck. Correction is recommended. Moisture stains on the underside of the deck indicate present leakage. Significant fungus growth was noted on the underside of deck. Probing revealed significant areas of damage. Refer to a qualified termite report for further information. We recommend further evaluation and repairs by a licensed contractor. The underside of the deck was not accessible because there was no access opening. Correction is recommended.

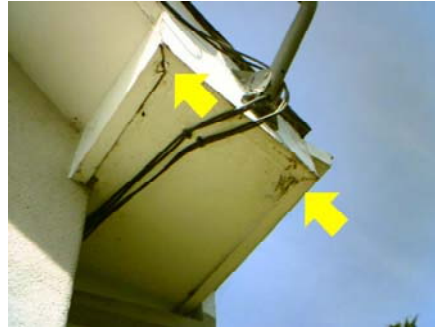
FACIA CONDITION:

General condition appeared serviceable with the exception of the following item(s): Damage was noted to the fascia on the right rear corner of the home. Damage or deterioration was noted to the paint or finish in a few areas. We recommend painting. Damage was noted to the fascia at the right front and front middle of the home. We recommend repair or replacement. Refer to a qualified termite report for further information.

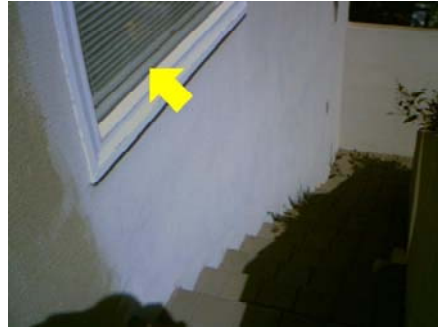
CONDITION:

The general condition appeared serviceable with the exception of the following item(s) listed below. A dry moisture stain was noted on the underside of the stairs. This may indicate past or present leakage. We recommend further evaluation and repairs by a licensed contractor. The window next to the stairs did not appear to be tempered glass. This is a safety hazard. We recommend the installation of a tempered window for safety enhancement.

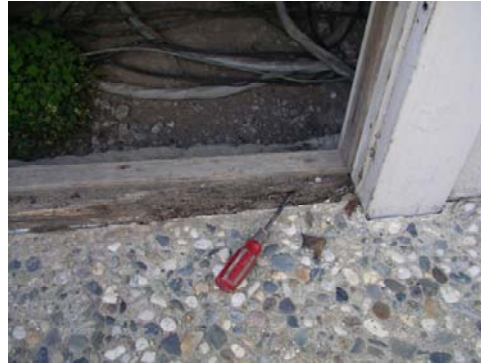
DOOR LOCATION/CONDITION:

The door to the crawlspace was located on the exterior right side of the home. The door to the crawlspace appeared serviceable at the time of our inspection. Damage was noted to the crawlspace door frame. We recommend lowering the soil level to prevent further damage. Refer to a qualified termite report for further information.

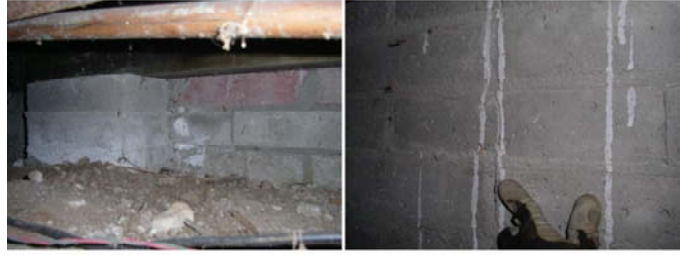
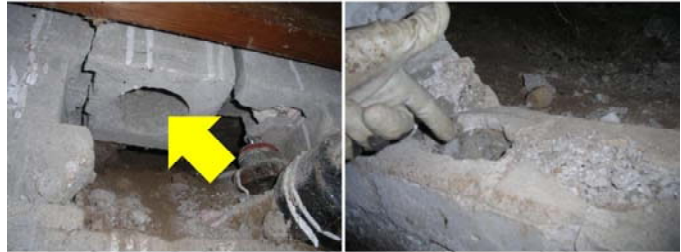
FOUNDATION CONDITION:

General condition appeared serviceable with the exception of the following item(s): We were unable to determine if there are foundation bolts installed on the home because of the type of beam installation. This is a potential structural stability concern because the house might not perform in an earthquake. We recommend consulting with a foundation contractor to determine if the installation of retrofit earthquake bolts is necessary or possible. We were unable to determine if the foundation was re-enforced with re-bar. Unre-enforced masonry is typically less resistant to cracking and settlement. I am guessing that it is an unre-enforced masonry foundation which appears to be performing fairly well. Cracks were noted in the foundation at the middle front. Although there did not appear to be any lateral movement of the foundation, it is important to keep the foundation acting as one continuous piece. When cracks are formed, sections of the foundation may settle at different rates. We recommend consulting with a foundation contractor and making repairs if necessary.

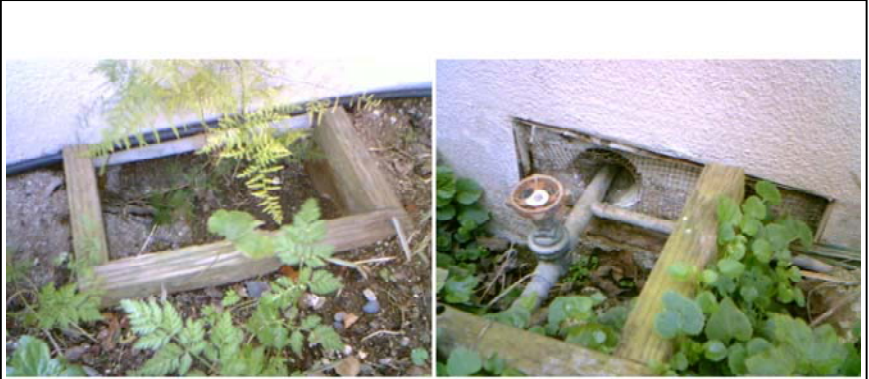
VENTILATION:

General condition appeared serviceable with the exception of the following item(s): Damage noted to vent screen(s) at the front of home. We recommend repairs to prevent pests from entering the crawlspace. Damage noted to vent screen(s) at the rear of home. We recommend repairs to prevent pests from entering the crawlspace.

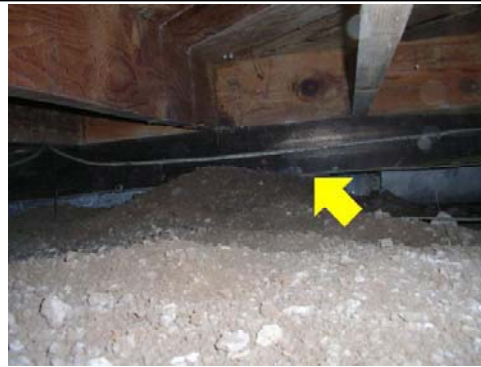
GIRDER CONDITION:

Appeared serviceable at the time of our inspection. Earth contact was noted to one of the girders at the front left. This can attract pests and damage to the wood. We recommend lowering the soil where necessary to prevent earth to wood contact.

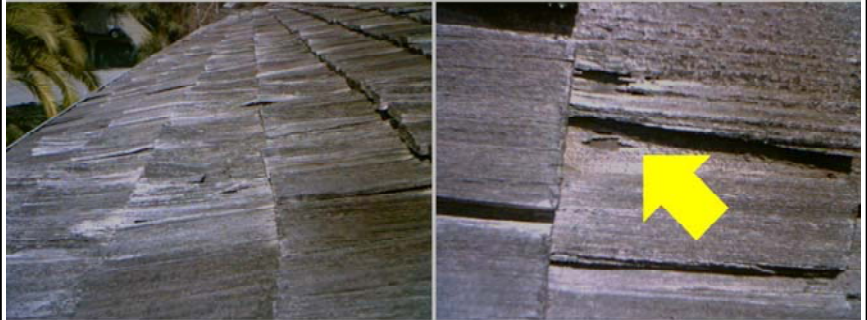
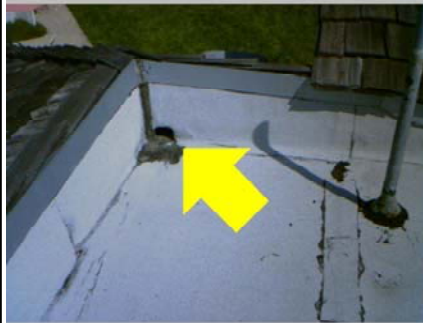
ROOF COVERING CONDITION:

Weathering and aging was noted to some of the roof shakes. Some of the shakes were weathered through to the tar paper underneath. It is important to replace weathered through shakes to prevent damage to the underlayment. The roofing material appears

to be nearing the end of it's useful life. We recommend replacement of the damaged shakes and further evaluation by a licensed roofing contractor. Cupping was noted to sections of the roofing material. This is when the shingles distort into a cup shape which can trap water. Roofs with this condition do not shed water properly and can be more prone to leakage. There appears to be a single drain through the parapet wall. A single drain can become clogged which can lead to a buildup of water on the roof. If a significant amount of water builds up, it can cause structural damage to the home. We recommend having a contractor install a second drain through the parapet wall.

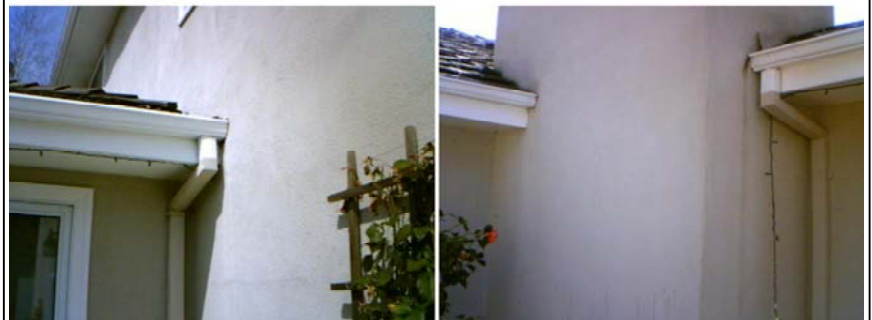
CONDITION:

General condition of the visible sections appeared serviceable with the exception of the following item(s): Rusting was noted to the flashings. You may wish to paint the flashing or have new flashings installed the next time that a new roof is installed. A proper kickout flashing at the rear garage roof to wall connection was not visible. This can allow water intrusion. We recommend having kick out flashings installed by a licensed roofing contractor. A proper

kickout flashing at the rear roof to chimney connection was not visible. This can allow water intrusion. We recommend having kick out flashings installed by a licensed roofing contractor.

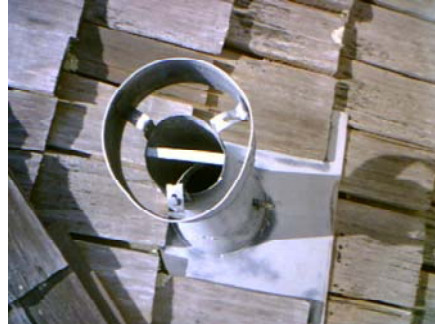
CONDITION:

General condition appeared serviceable with the exception of the following item(s): One of the vent caps appeared to be missing. We recommend replacement of the vent cap to prevent moisture intrusion.

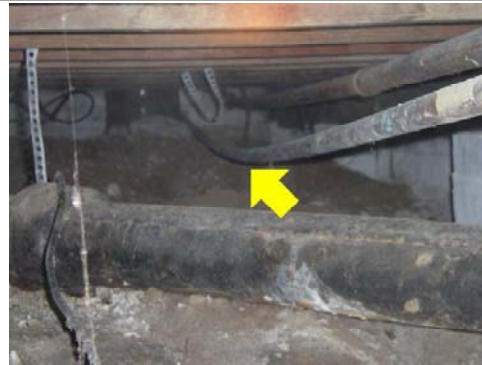
CONDITION:

General condition appeared serviceable with the exception of the following item(s): Supply plumbing lacked support in the crawlspace. We recommend strapping to prevent strain on the pipes.

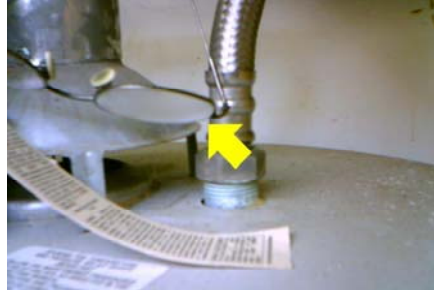
VENTING:

Fogging of glasses indicates gas leakage.

Back venting was noted at the draft hood. This means that instead of sucking in air at the draft hood vent gases are actually escaping. This is a health/safety hazard and correction is needed. We recommend further evaluation and repairs by a licensed venting contractor.

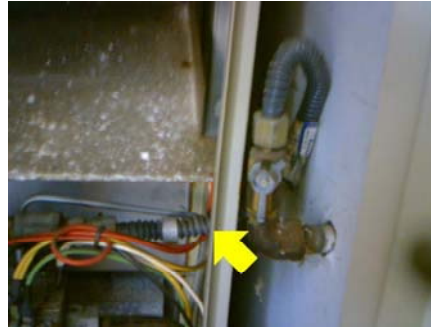
CONDITION:

General condition appeared serviceable with the exception of the following item(s): The furnace was an older unit. The typical lifespan of a furnace is between fifteen and twenty years. Many furnaces last well beyond this age. Because it was not fully visible, we recommend a leak test be performed by a heating contractor on the heat exchanger. We also recommend a yearly servicing by a heating contractor. A flexible type gas line was installed at the furnace. These flex lines can be subject to damage and leakage during earth quakes. They can also rub against the sheet metal of the furnace causing damage. We recommend upgrading the flex type gas line to a hard plumbing where it enters the unit for safety enhancement.

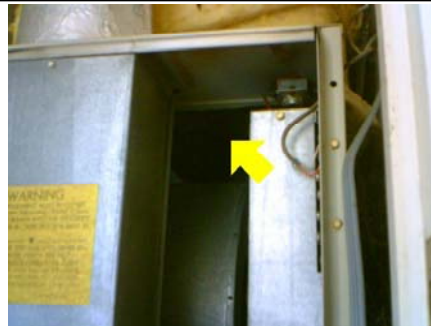
AIR FILTERS:

The filter was dirty. We recommend installing a new filter. The filter(s) were located inside the panel in the furnace. We

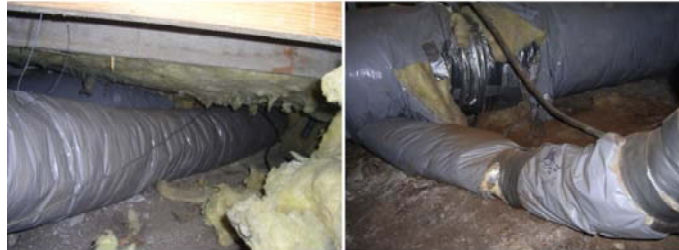
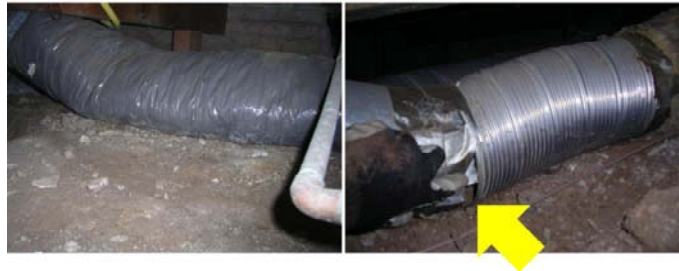
Several of the ducts were in contact with the ground in the crawlspace. We recommend strapping the ducts up to prevent moisture intrusion and damage. Crushed duct(s) were noted in the crawlspace. We recommend repair or replacement of the crushed sections of the ducts. A disconnected duct was noted in the crawlspace below the left front section of the home. We recommend repair. Damage was noted to the insulation in the crawlspace. We recommend repair or replacement. Evidence of rodent activity was noted inside the ducts. This is a possible health hazard. We recommend cleaning and evaluation by a qualified heating contractor. You may also wish to consult with a qualified exterminator.

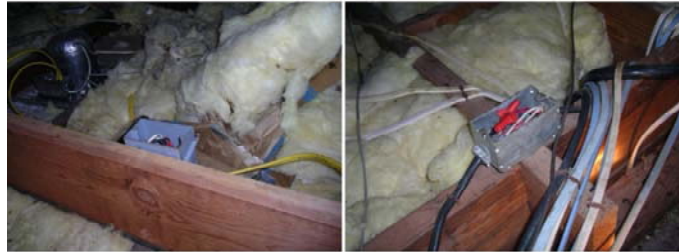
ATTIC WIRING NOTES:

The general condition appears serviceable with the exception of the following item(s) listed below. Several junction box(s) missing covers in the attic. This is a potential fire/safety hazard. Correction is recommended.

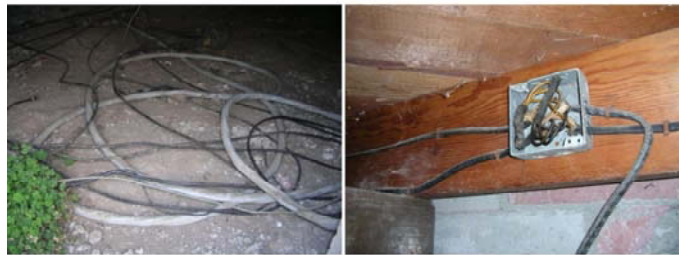
CRAWLSPACE WIRING NOTES:

Abandoned wiring was noted in the crawlspace. We were unable to determine if this wiring was still live. This is a potential safety hazard. We recommend further evaluation and repair by a licensed electrician. Some of the wiring in the crawlspace lacked support. Correction is recommended. Junction box(s) missing covers in the crawlspace. This is a potential fire/safety hazard. Correction is recommended.

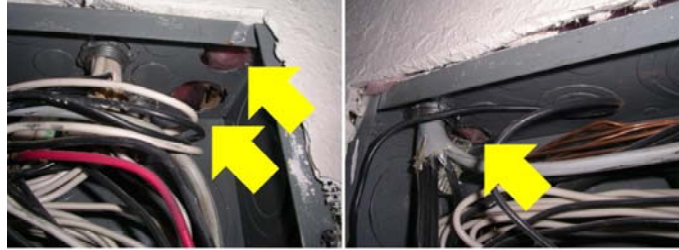
General condition appeared serviceable with the exception of the following item(s): Knock outs missing covers in the sub-panel correction is recommended. The color coding of the wires was improper. If a neutral line is being used as a hot conductor, it should be color coded as such. Correction is recommended.

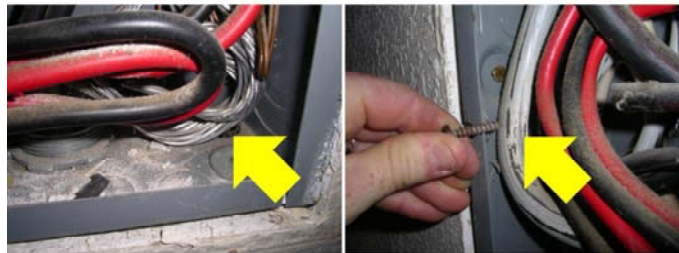
Luckily that wire does not carry current.

General condition appeared serviceable with the exception of the following item(s): Knock outs missing covers in the sub-panel correction is recommended. Wood screws were used to secure the dead front cover to the panel. This is improper because they have sharp ends and can damage the protective coating in the wires inside the panel. We recommend installing proper screws. This is a potential safety hazard. Correction is recommended.

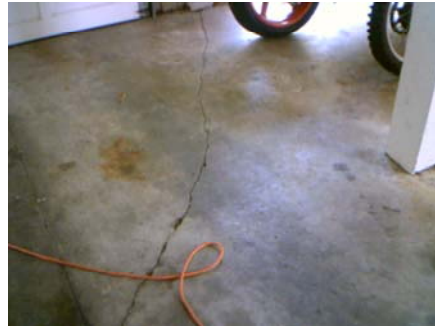
CONDITION:

Cracks were noted on the floor of the garage. Repairs will be necessary. We recommend evaluation and repair by a licensed contractor. The rear left corner of the garage floor appeared to be settled. This is typically caused by the patio drainage issue We recommend further evaluation and repair by a licensed contractor.

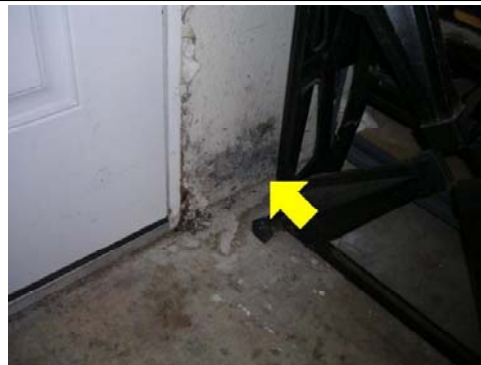
CONDITION:

General condition appeared serviceable with the exception of the following item(s): Moisture stains were noted on the back wall wall of the garage. Bio-organic growth was noted in the same location on the wall of the garage. Molds or fungus typically are caused by water leakage or improper ventilation. This is likely due to the patio slope. We recommend further evaluation by a qualified tradesperson. Some types of molds can be hazardous to your health. You may wish to have an air quality test performed to determine if a hazardous condition exists as this is outside of the scope of our inspection.

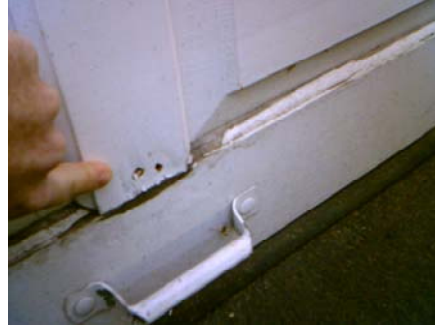
CONDITION:

General condition appeared serviceable with the exception of the following item(s): Damage was noted to the right and left garage vehicle door. We recommend repair or replacement. The exterior of the garage doors were in need of paint.

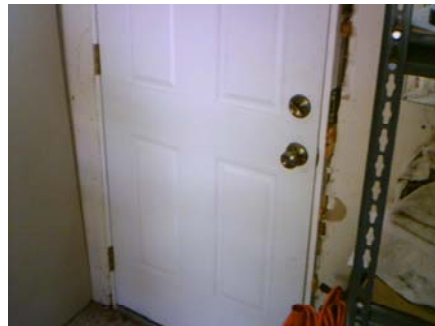
CONDITION:

This door was installed out of plumb. Correction is recommended. No trim was installed around the door. Correction is recommended.

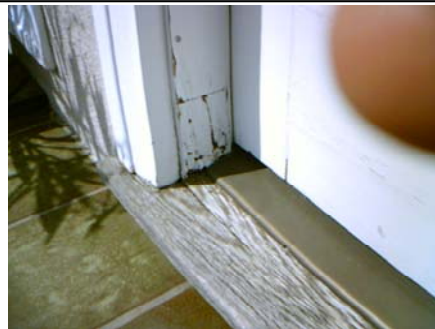
RIGHT EXTERIOR DOOR(S):

The weather stripping appeared serviceable. The hardware appeared serviceable. Damage was noted to the door jam. Refer to a qualified termite report for further information. We recommend repair or replacement of the door jam. The threshold at the door was improperly sloped. This can cause unwanted moisture damage to the threshold and door jam. Correction is recommended. Damage was noted to the threshold at the door. We recommend repair or replacement.

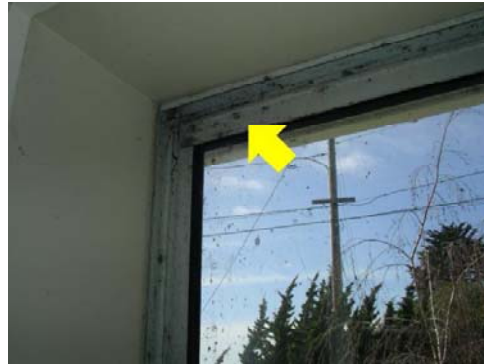
CONDITION:

General condition appeared serviceable with the exception of the following item(s): The dual pane windows were dirty at the time of our inspection. This makes determining the presence of fogged windows difficult. A few areas of what appeared to be bio-organic growth were noted on the windows and or window sills. Some types of mold can be hazardous to your health. You may wish to have this condition further inspected by a qualified expert in the field of bio-organic growth to determine if a hazardous condition exists as this is outside of the scope of our inspection. Some of the windows tracks were rough when opened. This can be an indication that the plastic sliders on the base of the window are missing or worn out. We recommend repair or replacement of the sliders as time permits. Scratches were noted in the windows on the family room. We recommend repair or replacement.

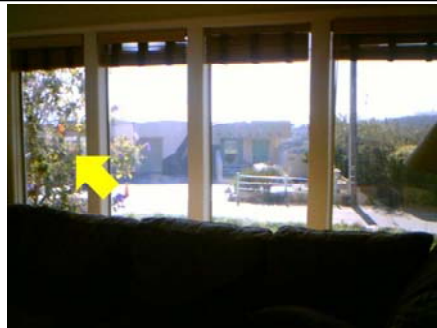
FOGGED WINDOW(S):

General condition appeared serviceable with the exception of the following item(s): Dual glazing appears to be fogged on windows in the following areas: family room. This is an indication that the seals on the windows have failed. On some types the windows can be re-sealed and on others it is necessary to replace the window. We recommend a full evaluation of all the windows in the home and repairs by a qualified window technician.

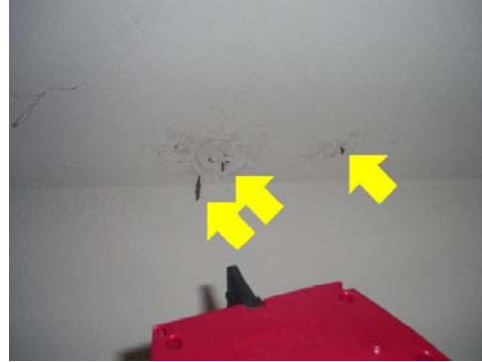
TYPE & CONDITION:

Drywall. Appeared serviceable at the time of our inspection. Flaking paint was noted on the ceiling in the foyer. Some types of older paint may contain lead which can be a health hazard. You may wish to have the paint tested to determine if it contains lead as this is outside of the scope of our inspection. We recommend scraping and re-painting. What may be termite tubes was noted in the left rear downstairs bedroom closet. Refer to a qualified termite report for further information.

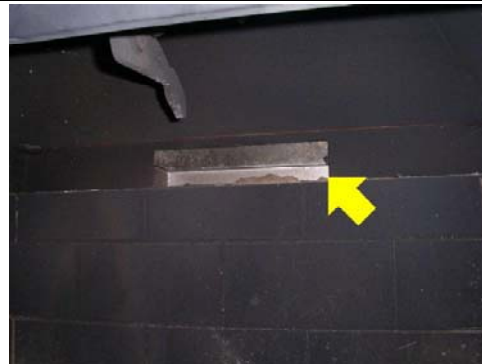
CONDITION:

Fireplace appeared serviceable. A small opening was noted just above the rear fire plate in the fireplace. I was unable to determine if this is supposed to have this opening or if a cover had been removed. We recommend further evaluation and repairs by a qualified technician. We also recommend asking the seller if the fireplace has been modified.

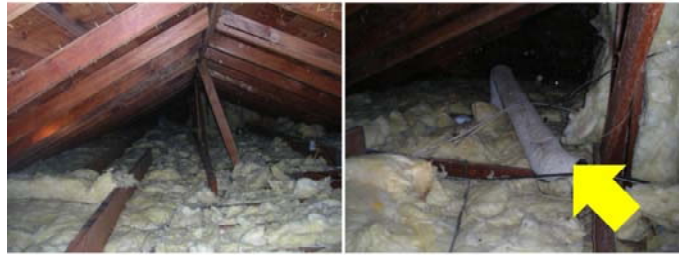
CONDITION:

The general condition of the attic appeared serviceable with the exception of the following item(s). Evidence of rodent activity was noted. You may wish to have treatment carried out by a licensed exterminator. Evidence of wood boring pest activity was noted in the attic. We recommend referring to a termite report for further information. Dry moisture stains were noted in the attic. These may be from a current leak. We recommend evaluation of the roof by a licensed roofing contractor. Two asbestos like vent pipes were noted in the attic. Asbestos is a potential health hazard. We recommend testing to determine if the vent pipes contain asbestos. We recommend removal by a licensed contractor.

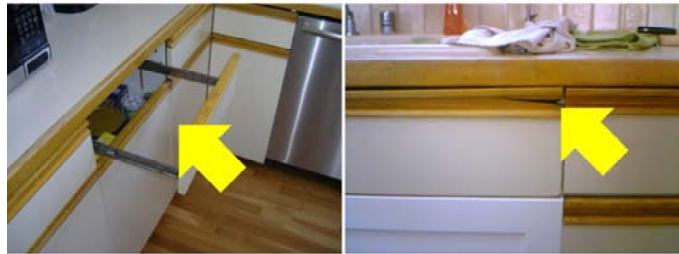
CONDITION:

General condition appeared serviceable with the exception of the following item(s): Calking is recommended for the kitchen counter behind the sink. Drawer(s) Missing. We recommend replacement of drawer(s). One of the handles was damaged. We recommend repair or replacement of the damaged handles.

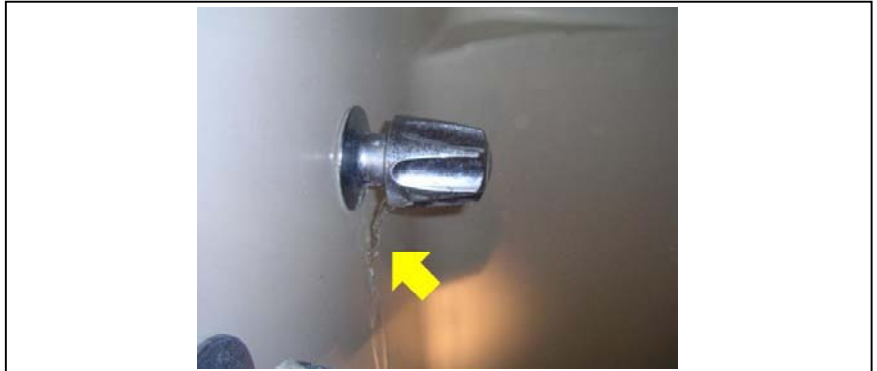
**TUB/SHOWER PLUMBING
FIXTURES:**

Drain appeared serviceable. Shower head appeared serviceable. Shower head was labeled 2.5 GPM and appears to be low flow. Leakage was noted at the faucet handles. We recommend repair or replacement of this fixture by a licensed plumbing contractor.
